Technical Guide.

Understanding brake judder and preventative steps.

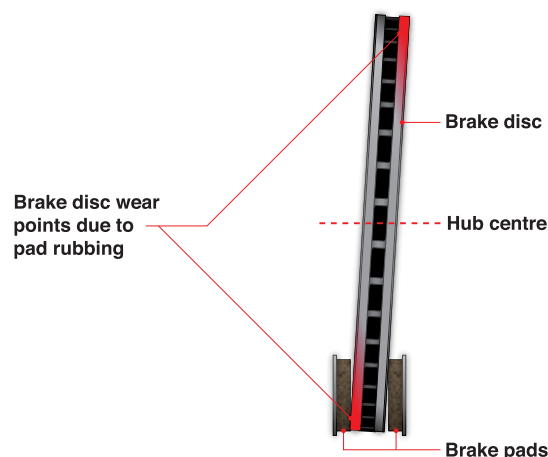
Lateral Run-out

Let's begin with the main cause of brake judder, Disc Thickness Variation (DTV), looking at the reasons why it occurs and successively, steps you can take to lessen the likelihood of its formation! One of the major causes of DTV is lateral run-out caused by improper cleaning of the hub surface. Similar to the butterfly effect, even the most minute particles of rust caught between the disc face and hub, (measuring as small as 0.04mm), can lead to lateral run out (where the turning disc starts to deviate from its axis) in excess of 0.1mm when measured at the centre of the braking surface. The important point to note is that while this deviation may not immediately induce brake judder, it has provided the foundations for a vibration that will eventually lead to it and potentially irreparable damage to the braking disc, although this may not occur for over 2000-5000 driven miles.

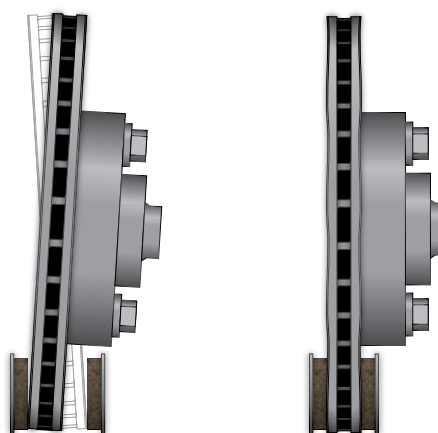
Thickness Variation

Customers affected by brake judder often jump to one conclusion; that they are experiencing a side-effect of warped discs or more technically (distortion). Although brake discs can warp, in reality DTV (disc thickness variation) is the most common cause of judder.

Technicians must check disc thickness before refitting a disc, as if outside manufacturer tolerances it is not a serviceable item and requires replacement. Technicians are advised to pick eight equidistant points around the perimeter of the disc and to never base a determination of thickness on a single spot. Any variation in disc thickness will translate into brake judder.

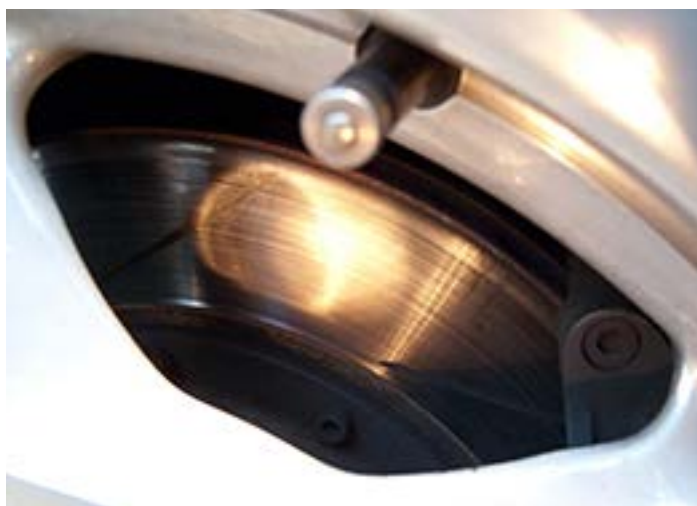
braking which would elevate the temperature of the disc and pad. All Apec brake pads go through a 'High Pressure Treatment' process, burning off many of the resins and gases at the factory that would normally find their way into the atmosphere during bedding-in; this gives a good initial braking performance (green performance). During the bedding process a layer of friction material is evenly distributed across the brake discs. Too little heat during bedding keeps the material from transferring to the rotor face thus avoid feathering the brake pedal while overheating the system can generate uneven pad deposits due to the material breaking down and sticking to the disc, causing a Stick/Slip situation.

Once this has happened, heavy braking will lead to uneven heat build-up due to the uneven distribution of friction material across the disc, with high-spots heating excessively in comparison to the rest of the disc. If the temperature at these high-spots exceeds 650 deg. C, cast iron changes structurally, transforming into an im-mensely rigid substance called Cementite! As the disc is now composed of varying materials of different strengths, judder will progressively worsen, which explains why customers often return with their vehicles months after installation. This cause may be as simple as poor technique, using the brake pedal to slow the car rather than engine braking on serious inclines and repeated emergency stops without adequate cooling time!

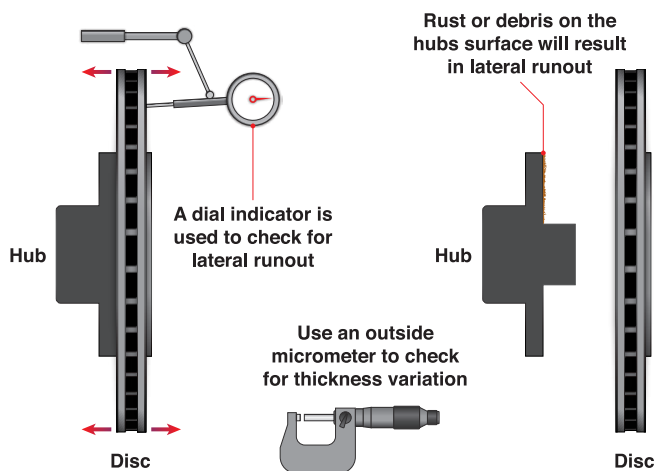
Technicians must always check lateral run-out, even when fitting new discs. Using a dial indicator, use 0.05mm to 0.10mm" as your maximum run out limit.

If you want to check run out of the discs independently of the hub, check the disc on a lathe and perform a dial indicator reading. In an effort to remove variables from the equation, make a run out reading of the hub flange itself, without disc. If the flange itself is causing the run out problem, you'll be able to isolate the cause.
