# Technical Guide.

## Corrosion and how it affects braking systems.

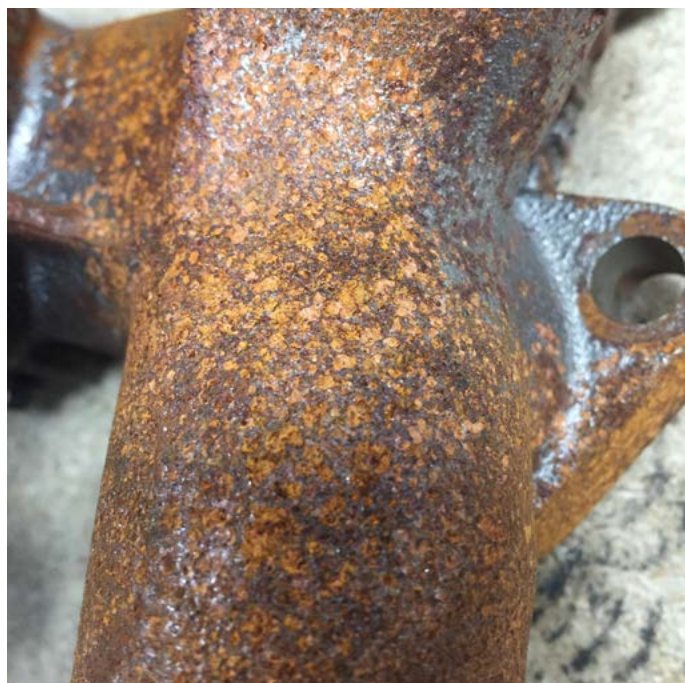
Corrosion is a natural process that deteriorates metal or its properties because of a reaction with the environment. The corrosion that we are most familiar with is the formation of rust on the surface of metals when they are exposed to Oxygen and moisture. Rust is Hydrated Iron (III) Oxide which is the by-product produced by this reaction. Scientifically this is an electrochemical process which returns metals to a thermodynamic state.

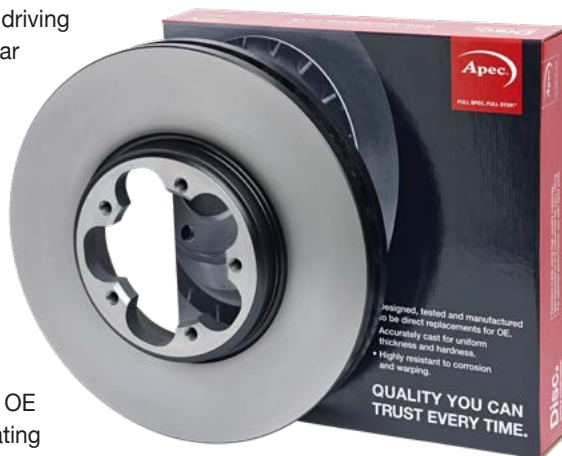
with a black coating for effective protection and long-lasting smart appearance. There is no coating on the friction surface to contaminate the pads and reduce their efficiency. However, corrosion does become an issue when the brake discs are left stationary for a long period of time in an area that has more than 80% of relative humidity. Corrosion on the surface of the brake disc can lead to an increase in NVH (noise, vibration and harshness) and reduce braking efficiency. In more extreme cases this can lead to corrosion adhesion between the brake disc and pad that can cause severe damage.

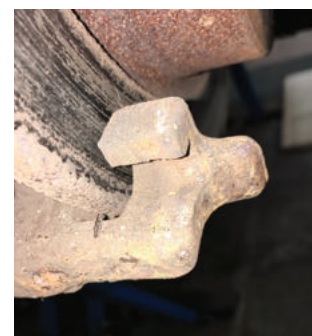
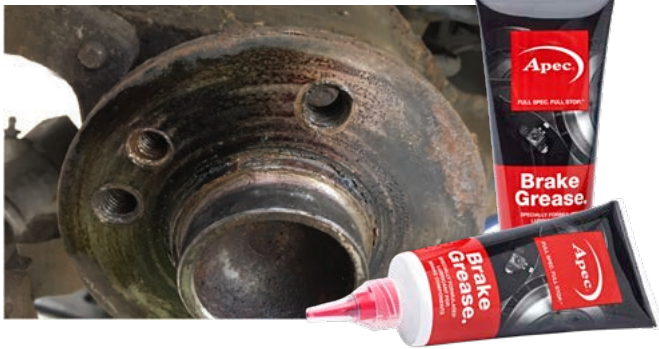
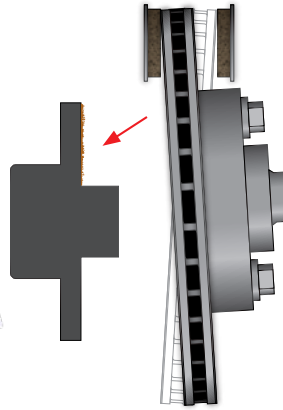
Components surrounding the discs and pads are also susceptible to corrosion. To ensure the optimum performance, the components must be treated to combat the effects of corrosion. Free movement is essential for the brakes to be effective, therefore contact points that are susceptible to corrosion must be lubricated with the correct

lubricant to facilitate free movement and protect the area. The lubricant used must be able to withstand high temperatures and must be completely metal free to avoid galvanic corrosion that will restrict movement. Apec Braking provide a petroleum-based lubricant that effectively protects surfaces as well as being fully compatible with ABS and ESP braking systems.
